A Proposed Mechanism and Remedy for Ball-in-Socket and Foot-in-Mud Soldering Defects on Ball Grid Array and Quad Flat Pack Components

Brian Smith
Kester
Des Plaines, IL

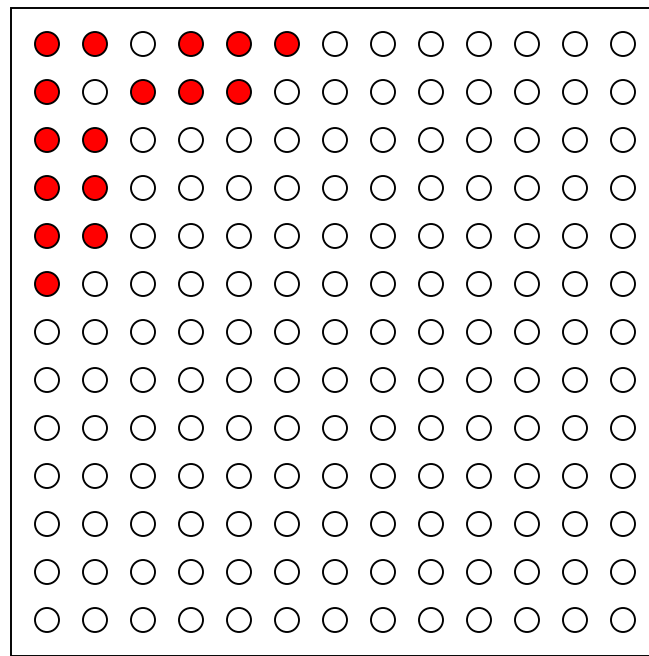
Note that all of the defect locations represented in Figure 3 have occurred in the top-left corner of the component. This type of repeatability in one geographical area of the component could not be caused by poor solderability, inadequate paste height/volume, or component co-planarity. Another root cause must be the culprit in this type of defect. The purpose of this work is to propose another potential root cause and identify a remedy for these defects.

Figure 3 – Typical BGA Ball-in-Socket Defect Map

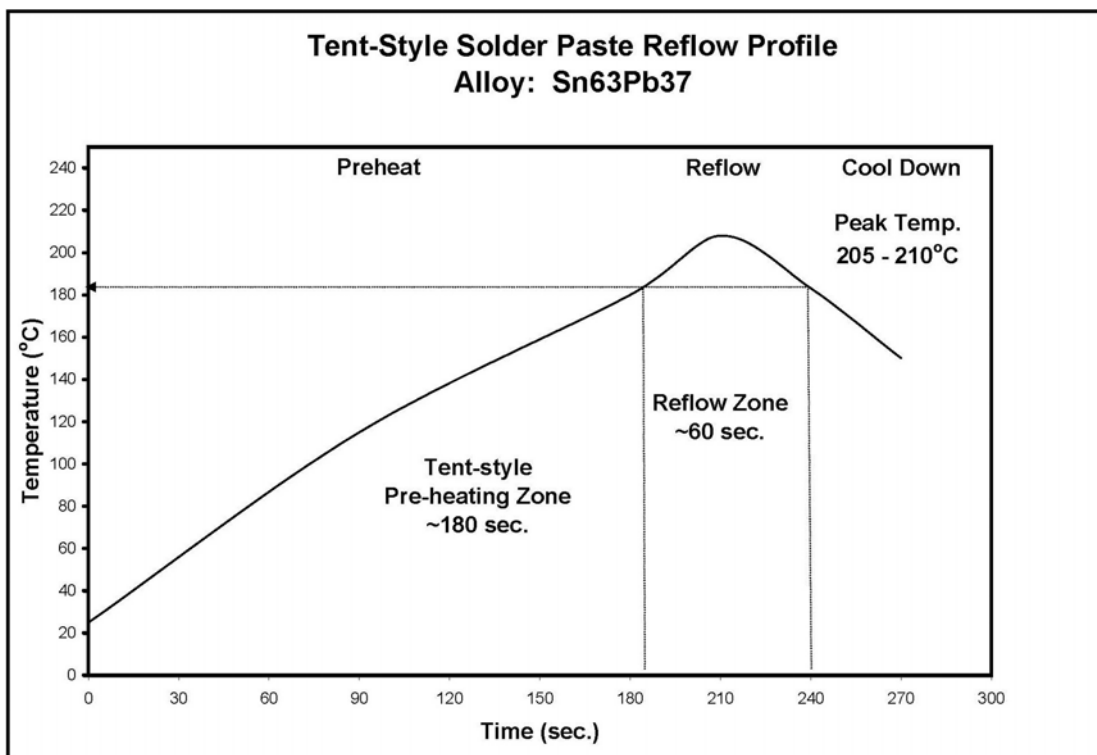
Figure 4 – Reflow Profile Used at Customer A

This profile is of the “ramp-to-spike” (or “tent”) variety with no discernable soak zone. The ramp rate was a steady 0.9 – 1.0 °C/sec for the pre-reflow portion of the profile and the peak temperature was 205-210 °C. After measuring the temperature on all four corners of the component, it became evident that the ball-in-socket defects were occurring on the coolest corner of the component. Furthermore, the Delta T across the component was ~7 °C as the hotter corner reached the reflow temperature (183 °C), leading to a significant difference in melting times. This difference in temperature was driven primarily by the other components surrounding the large BGA, but was also exacerbated by the fact that the hotter corner was at the leading edge of the component and would therefore sooner experience the higher temperature of the subsequent reflow zones in the oven. A basic schematic of the board is shown in Figure 5.

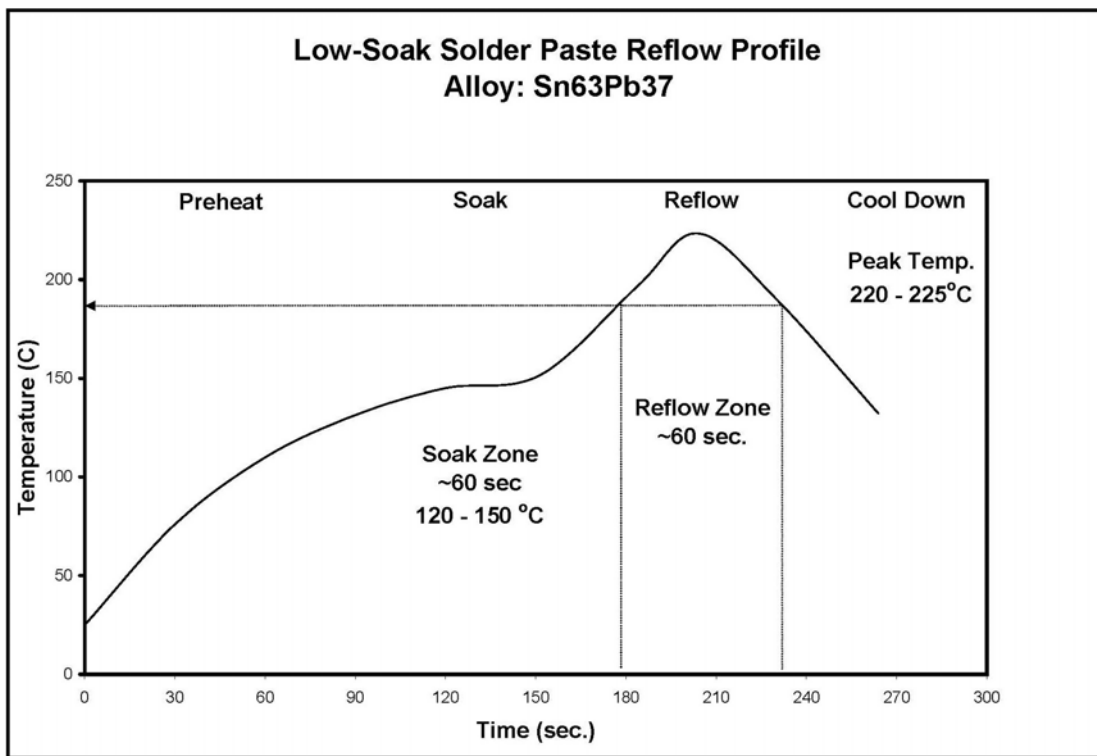
Figure 6 – Reflow Profile Used at Customer B

Note that the reflow profile used at Customer B is a “ramp-soak-spike” with a soak temperature of 120-150 °C and a peak temperature in the range of 220-225 °C. Upon performing a reflow profile specifically on the component demonstrating the foot-in-mud defects, it was found that the cooler corner of the component was the location of all of the foot-in-mud defects. It was noted that the Delta T from the cooler corner to the hotter corner was ~6 °C as the hotter corner reached the reflow temperature. This led to the hotter corner melting several seconds before the cooler corner.
