### **Lead-Contamination in Lead-Free Electronics Assembly**

Karl Seelig and David Suraski

AIM

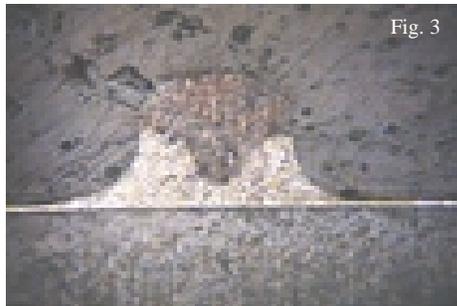
Fig. 3 illustrates how much of a lead sphere dissolves into a Sn/Ag system during a normal reflow cycle. Fig. 4 is a close-up of Pb pockets that are dispersed through a Sn/Ag system. This dispersion is a common part of wetting: as the solder wets, the Pb dissolves into the joint.

As the Pb starts concentrating in pockets, this starts forming a eutectic of Sn/Pb/Ag with a melting point of 179°C vs. 221°C for Sn/Ag or 217-218°C for Sn/Ag/Cu. This phase occurs during cooling, and the slower the cooling, the larger the pocket of this lower melting temperature alloy will form. In essence, this pocket of alloy acts as a void in the solder joint. As the component heats and cools during its product life, this void will eventually lead to joint failure. Failure rates related to this issue typically occur relatively quickly (in less than 400 thermal cycles).
