A Proposed Mechanism and Remedy for Ball-in-Socket and Foot-in-Mud Soldering Defects on Ball Grid Array and Quad Flat Pack Components

Brian Smith
Kester
Des Plaines, IL

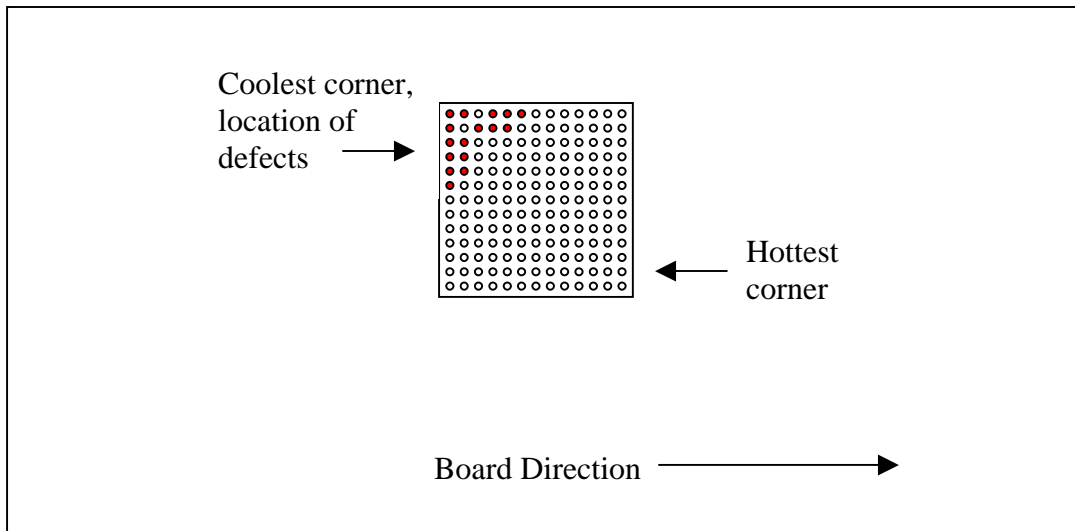
Figure 5 – Schematic of the Board at Customer A

This profile is of the “ramp-to-spike” (or “tent”) variety with no discernable soak zone. The ramp rate was a steady 0.9 – 1.0 °C/sec for the pre-reflow portion of the profile and the peak temperature was 205-210 °C. After measuring the temperature on all four corners of the component, it became evident that the ball-in-socket defects were occurring on the coolest corner of the component. Furthermore, the Delta T across the component was ~7 °C as the hotter corner reached the reflow temperature (183 °C), leading to a significant difference in melting times. This difference in temperature was driven primarily by the other components surrounding the large BGA, but was also exacerbated by the fact that the hotter corner was at the leading edge of the component and would therefore sooner experience the higher temperature of the subsequent reflow zones in the oven. A basic schematic of the board is shown in Figure 5.
