## Relationship Between Via Size and Cleanliness

Eric Camden  
Foresite  
Kokomo, Indiana

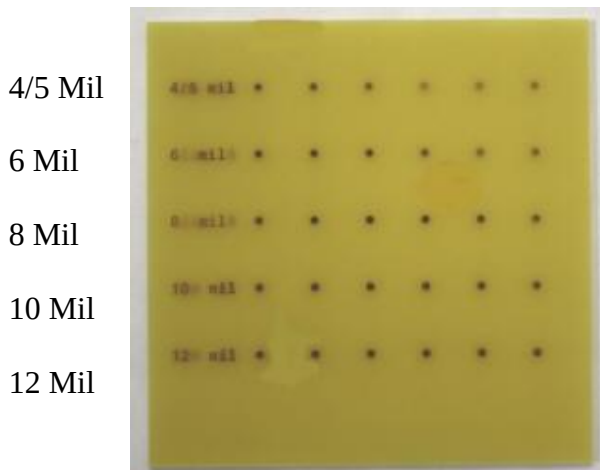
**Figure 1-Via Test Board**

After receipt of the test boards each containing 5 different sizes of microvias, our team began its ionic cleanliness investigation by extracting localized samples from the microvia sites along with a bare board reference site. This was accomplished by utilizing the C3 localized cleanliness tester to effectively penetrate and flush out the via with a localized burst of deionized steam allowed to soak and draw out ionic contaminants. This localized sample is then aspirated into a testing cell containing a y-electrode that provides an immediate spot-check as to the cleanliness of the sample based on predetermined cleanliness parameters. Though the immediate 'clean' or 'dirty' reading provides a good indicator as to the contamination level of the sites in question, our study aimed to examine the exact types and quantities of residues present with more specificity. Figure 2 shows an example of the flow thru achieved with the localized tester. Actual testing was performed with Kapton® tape covering the bottom side of the open vias to stop the flow of extraction solution and allow for IC testing of solubilized residues. Photo is meant to show evidence of effectiveness of extraction procedure. Data points of bare reference areas as well as tape samples were tested and subtracted from the IC totals.

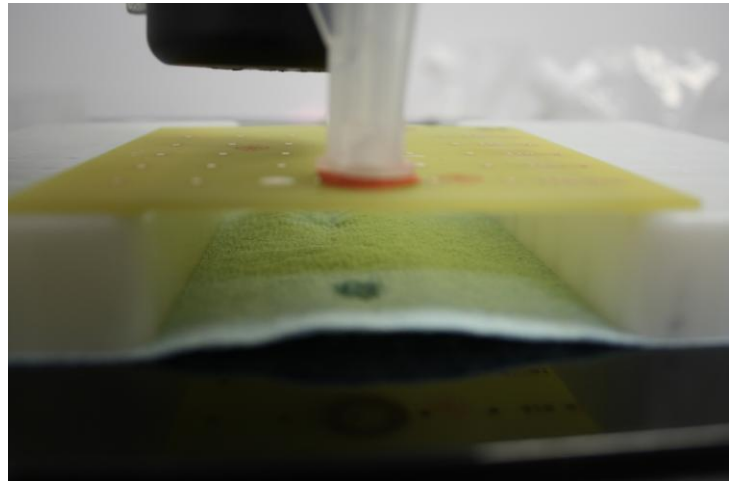
**Figure 2- Localized Extraction Example over 4/5 Mil via**

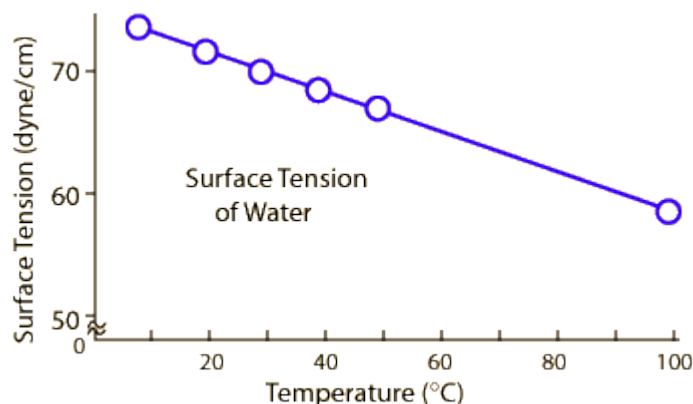
**Figure 3-Surface Tension of Heated Rinse Water**

When considering via cleanliness, Foresite's hypothesis lies in the thought that the surface tension of heated deionized water does lower the surface tension (figure 3) it is still too high to properly flush out and clean all of the etchant residues in the microvia sites. Lower surface tension makes it a better "wetting agent" to get into pores and fissures rather than bridging them with surface tension. Saponifier and wetting agents further lower the surface tension.

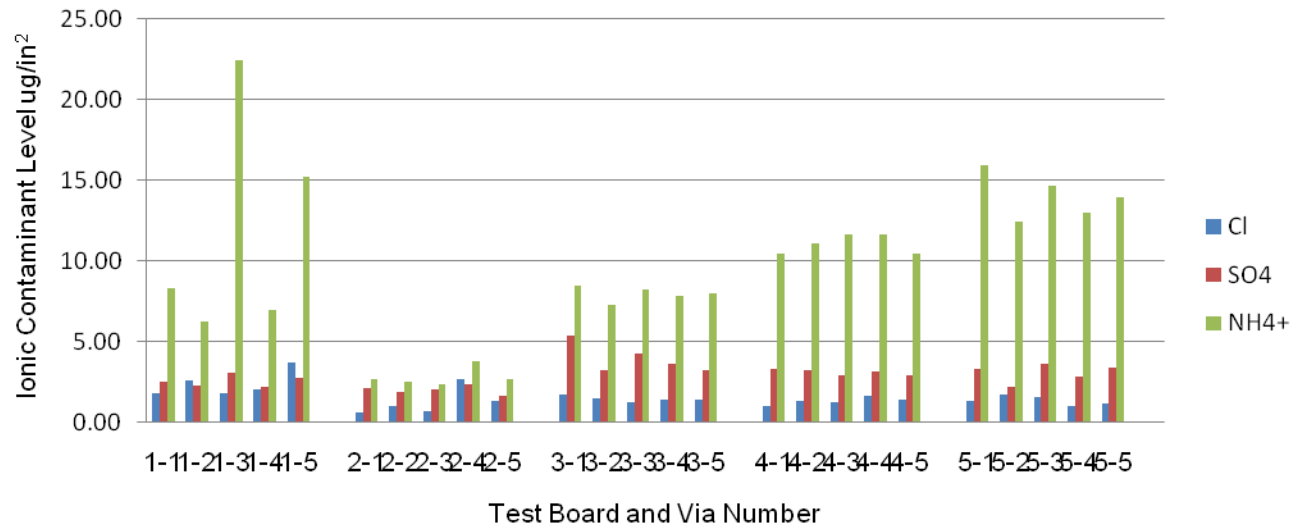
Table 2-Ionic Cleanliness Levels - 6 Mil Vias

Data shows that there is a very wide range of amounts of contaminants in each and every via size tested. The bare reference areas tested show low levels of chloride and sulfate with fairly high levels of ammonium (table 6) so we can say that the residues are confined to the vias themselves and not other outside factors. The levels of contamination from test board to test board are a varying factor that we did not anticipate, as the five test boards selected were chosen as the first five out of a sealed package. Test board number two shows lower levels of all contaminants in vias of all sizes when compared to the other four test boards. This proves the inconsistent nature of rinsing on not only different via sizes but also boards within the same lot. In general the test results show that via sizes of 10 and 12 mils are cleaner than those under 10 mil with a few outliers. We believe that this only furthers the need to better understand levels of cleanliness inside vias of all sizes.

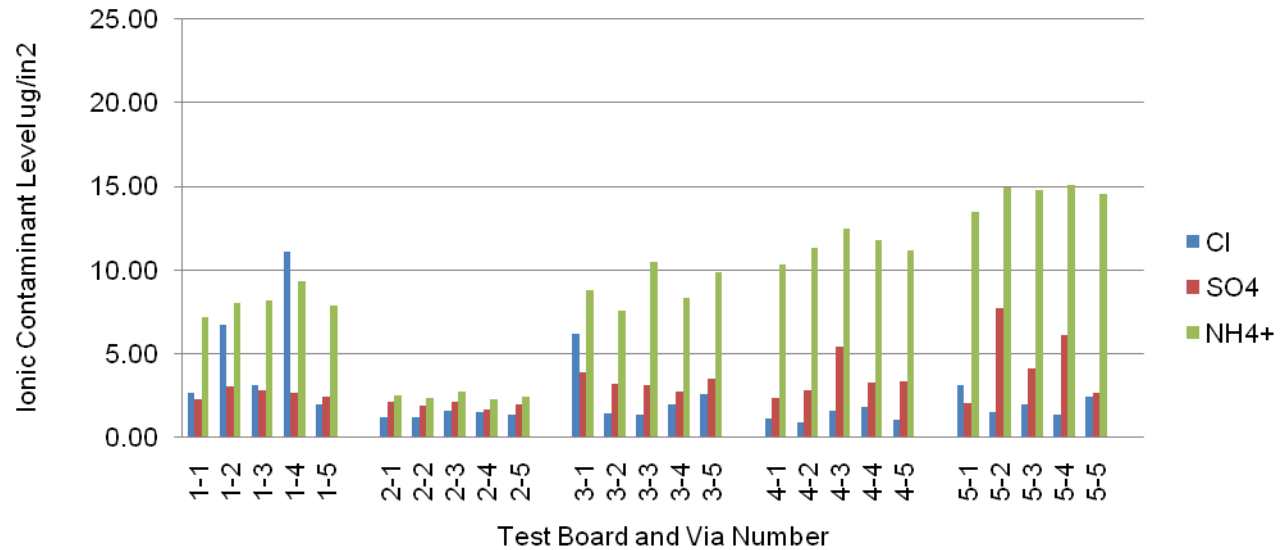
Table 3-Ionic Cleanliness Levels - 8 Mil Vias

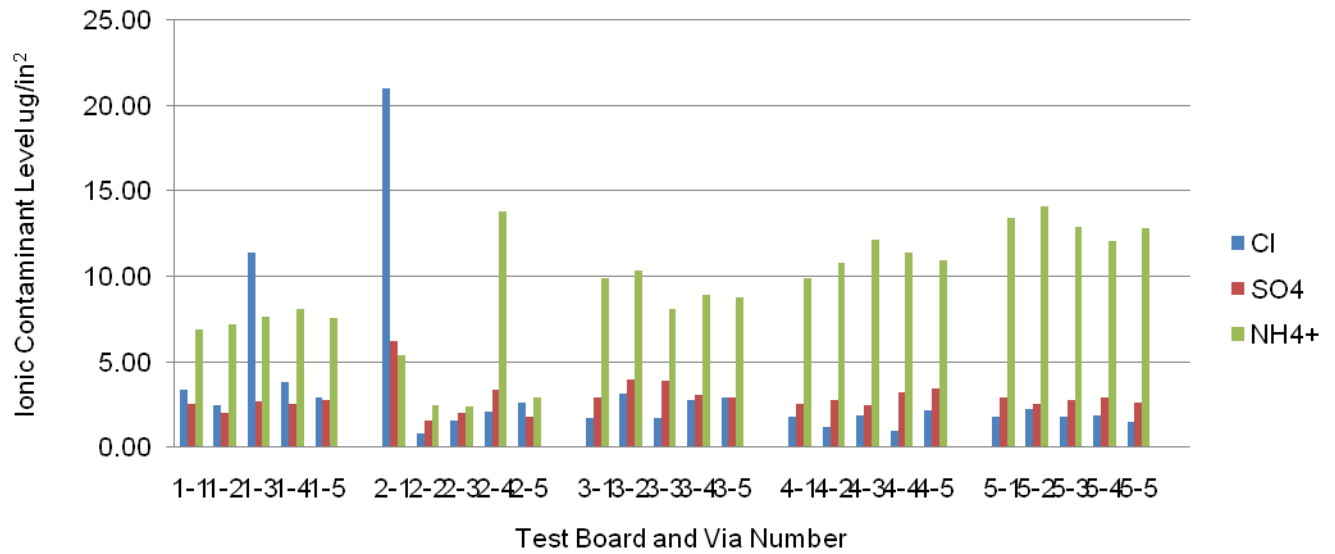
Table 4-Ionic Cleanliness Levels - 10 Mil Vias

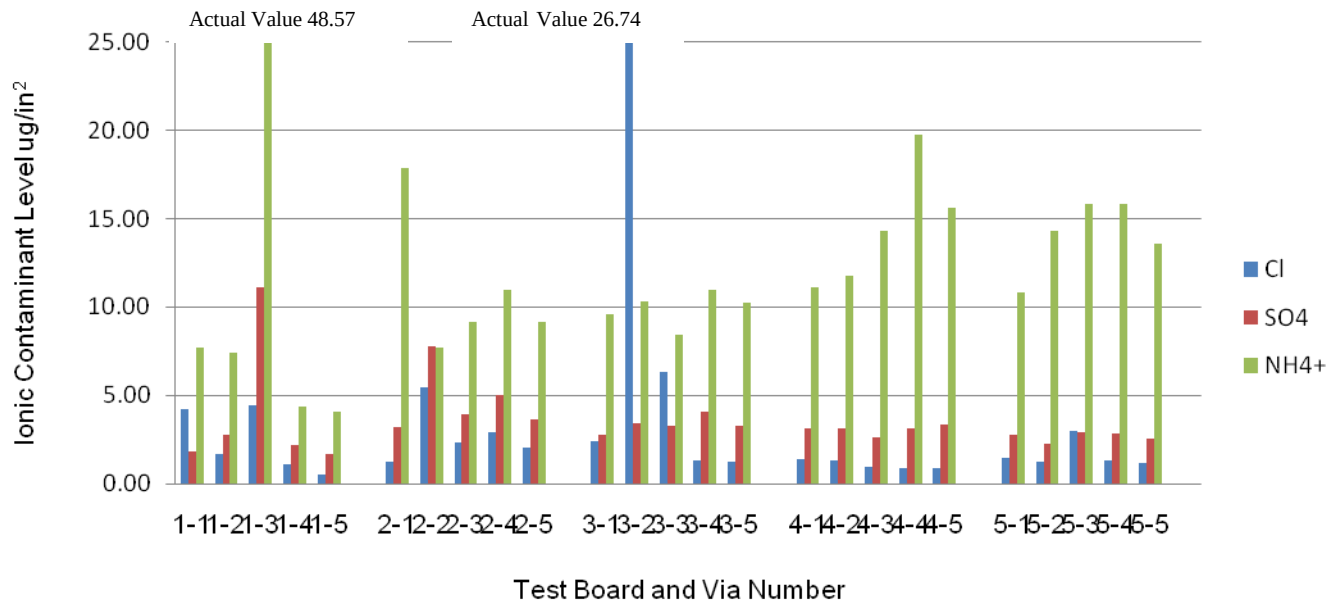
Table 5-Ionic Cleanliness Levels - 12 Mil Vias

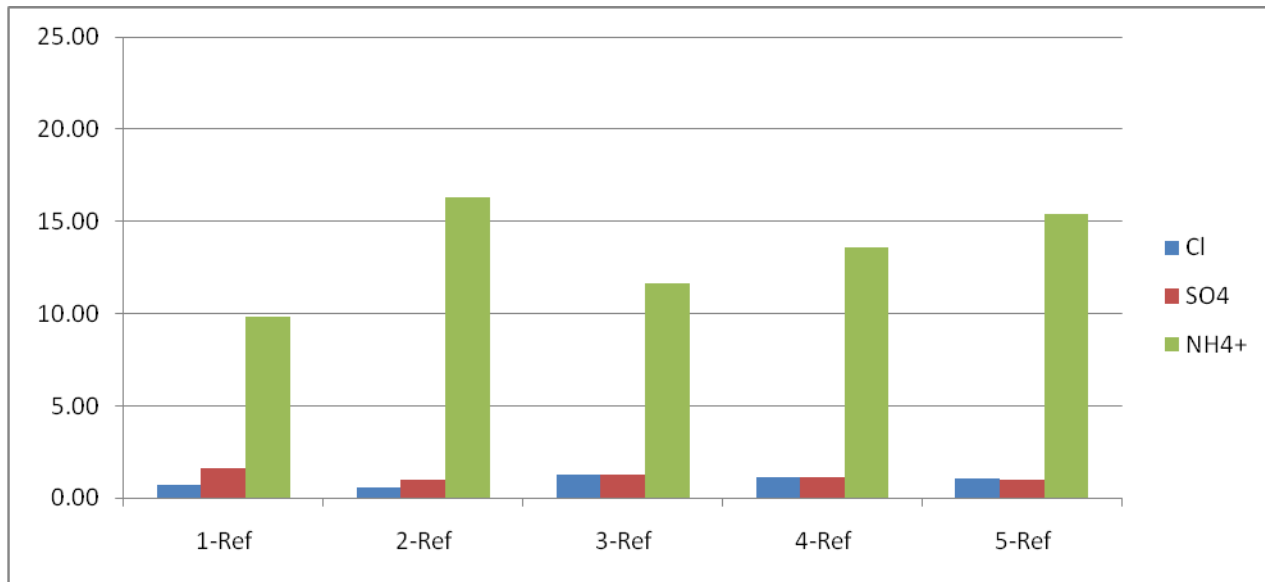
Table 6-Bare Board Reference Areas Away from Vias
